MERRIMACK RIVER BASIN
MANCHESTER, NEW HAMPSHIRE

**MASSABESIC LAKE DAM
NH 00103**

**PHASE I INSPECTION REPORT
NATIONAL DAM INSPECTION PROGRAM**

AUGUST 1978

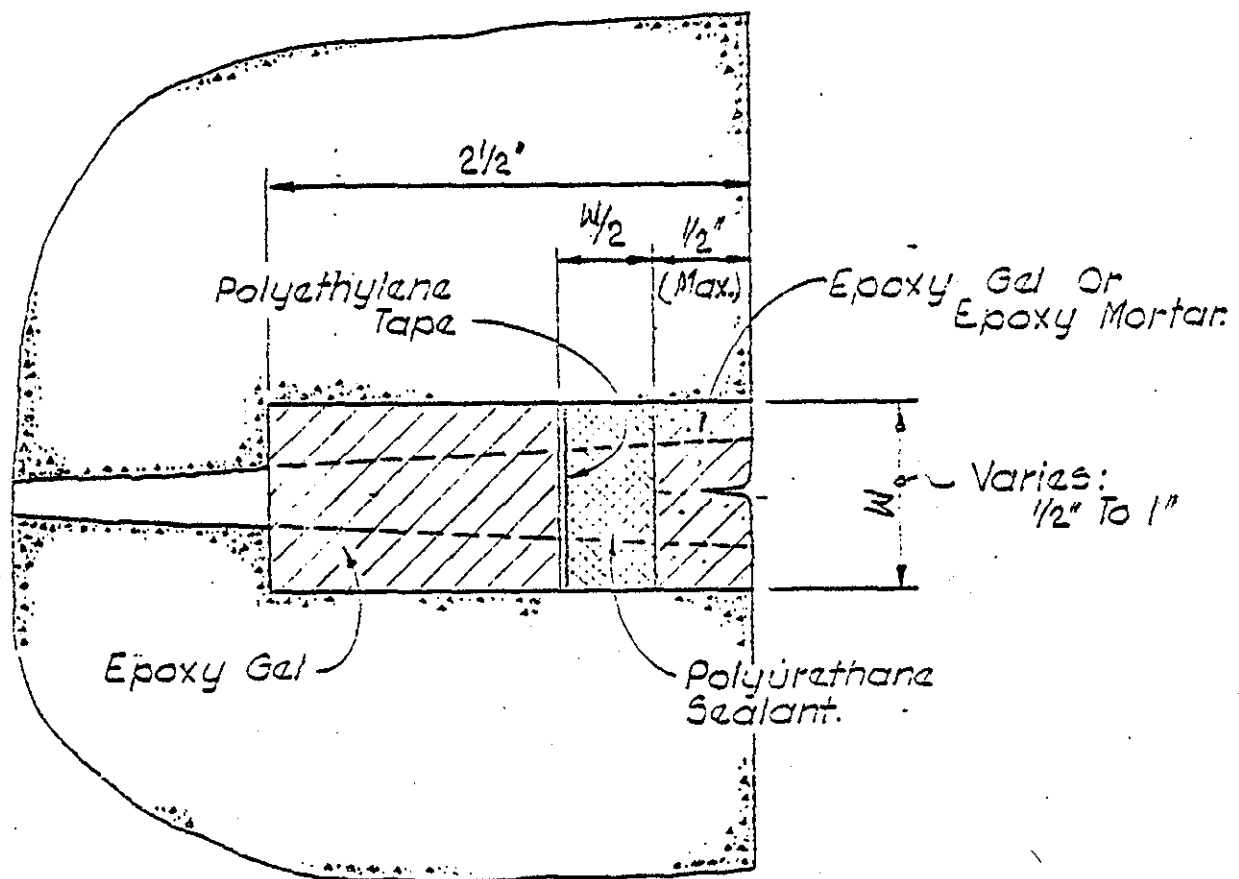
CRACK REPAIR

1. The average crack width is $3/8"$ to $1/2"$ with one crack being $1"$ wide.
2. The depth of the cracks are $3"$ to $4"$.
3. The cracks are subjected to a maximum back pressure of about 25 feet of water although none are leaking and only a little dampness is present in some.
4. It is assumed the cracks are working shrinkage cracks and they do not impair the adequacy of the structure.

1. Using a saw tooth bit, widen the crack slightly ($1/2"$ minimum width) by cutting a trim, narrow, sharp edged groove to a depth of 2-1/2 inches.

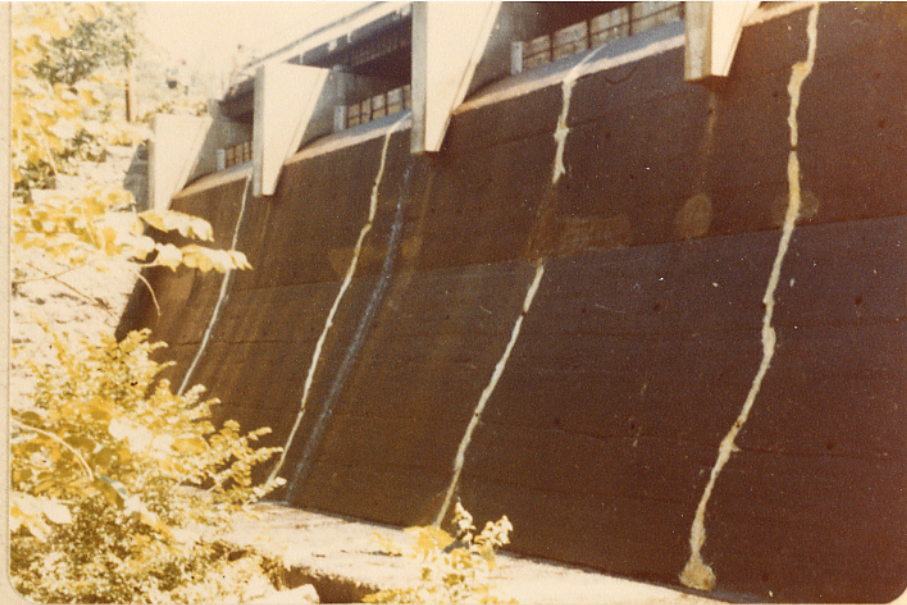
The face of the spillway has several vertical cracks that run nearly the entire height of the dam. These cracks were repaired with an epoxy sealant in 1975. Approximately 50 weep holes were observed in the spillway face; those that could be readily reached were from 2' to 5' deep and fairly clear. The flashboards were securely bolted to the sides of the piers and it is unlikely that they would fail from a head less than the available freeboard.

The reason for the vertical cracks in the spillway is unclear and has not been fully investigated. Although it is reported that these cracks did not leak, and that the epoxy sealant has bonded securely, it would be prudent to find the reason for their development.

| 10 | View of spillway from toe of southwest abutment showing epoxy repairs to vertical cracks. Also note large number of weepholes. |

The owner should retain a competent engineer with special experience in structural problems of dams to investigate the cause or causes of the vertical cracking in the spillway, and to implement a remedy if necessary.

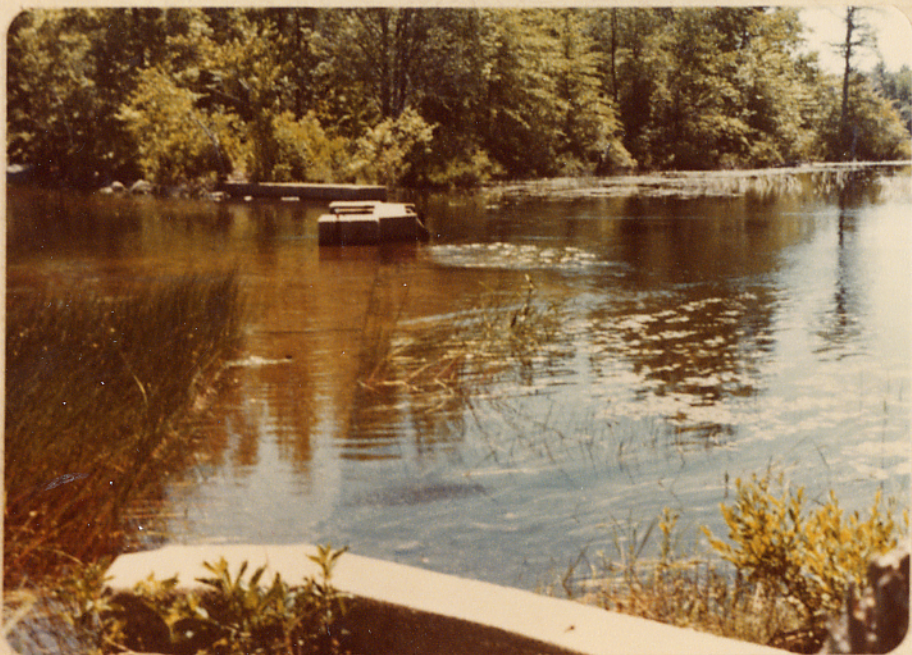
The Cofferdam appears in serviceable condition.

| 11 | Cofferdam from right side. Note submerged walls and top of sluiceway above water. Downstream is to the right. |

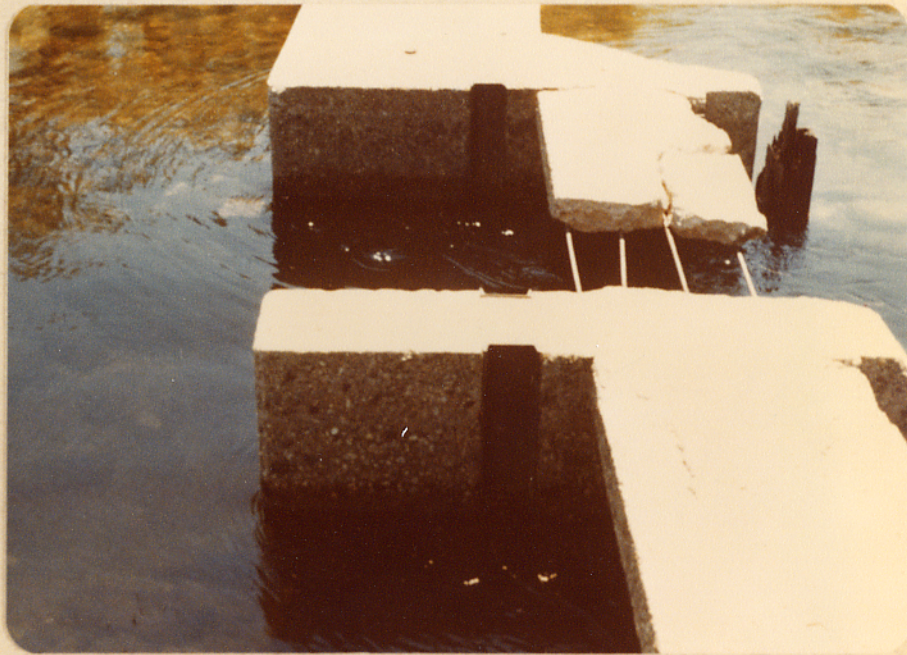
| 12 | Detail of cofferdam sluiceway. Depth to bottom about 6 ft. Plank partially wrecked. |
